West Virginia Chemical Leak
Etowah, Kanawha County, West Virginia
TDD No TL01-14-01-001

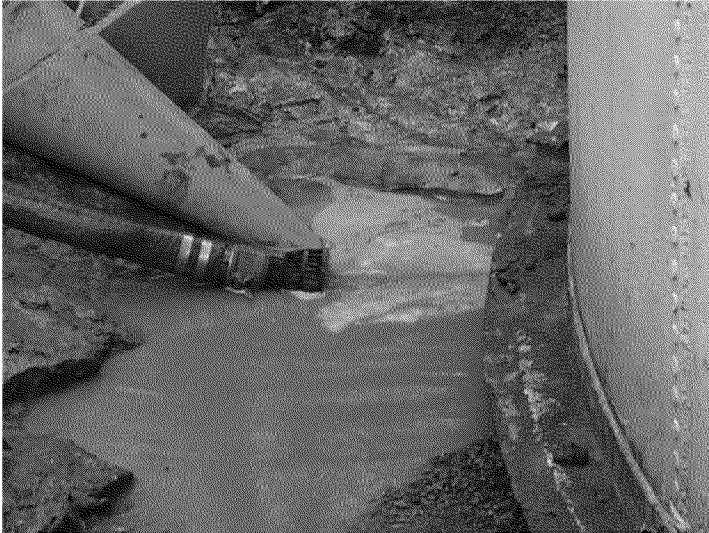
Photo No. IMG_0004; Taken on 03/02/14 at 9:07 hours by START JW. Contamination is visible on the surface of the water beside tank 395.

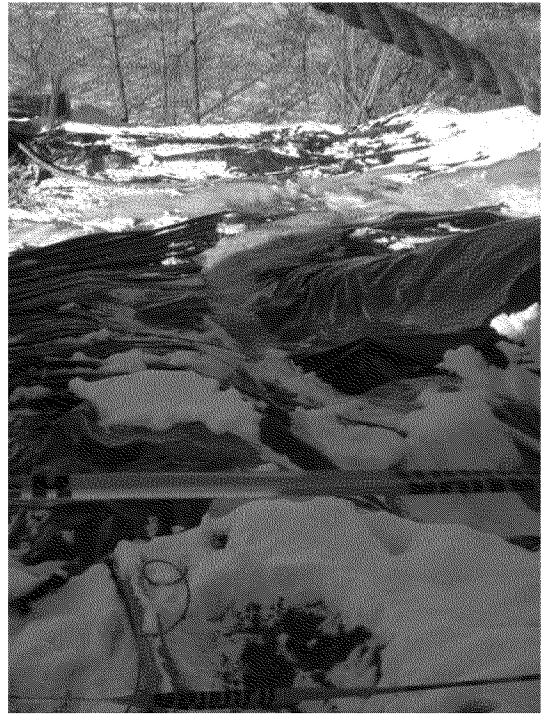
Photo No. IMG_1226; Taken on 01/24/14 at 11:42 hours by START GN. Ice covered water in collection trench

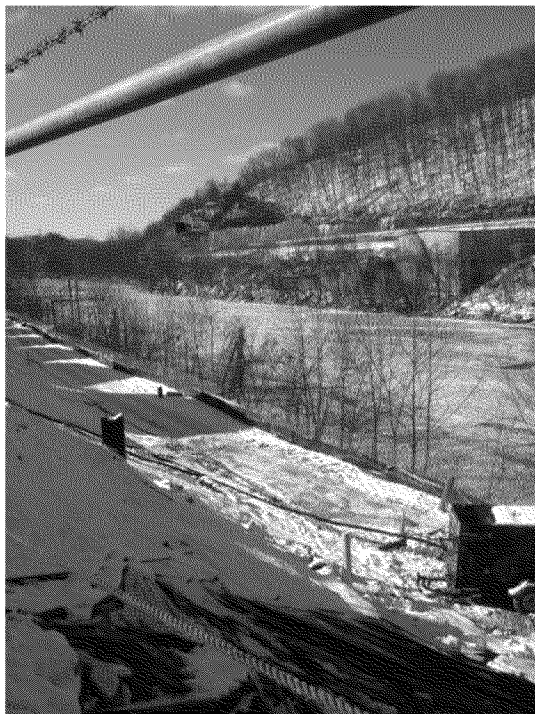
Photo No. IMG_1227; Taken on 01/24/14 at 14:32 hours by START GN. Ice cover on Elk River

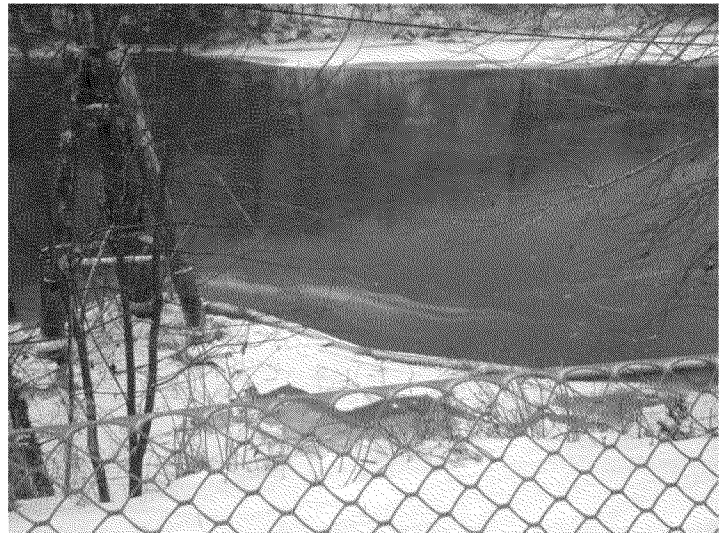
Photo No. IMG_1232; Taken on 01/25/14 at 13:01 hours by START GN. Ice forming in Elk River.

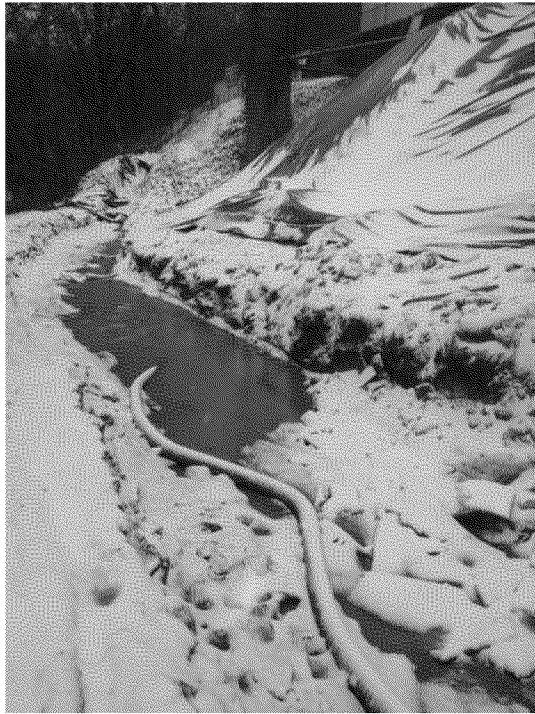
Photo No. IMG_1248; Taken on 01/27/14 at 16:18 hours by START GN. Water in collection trench.

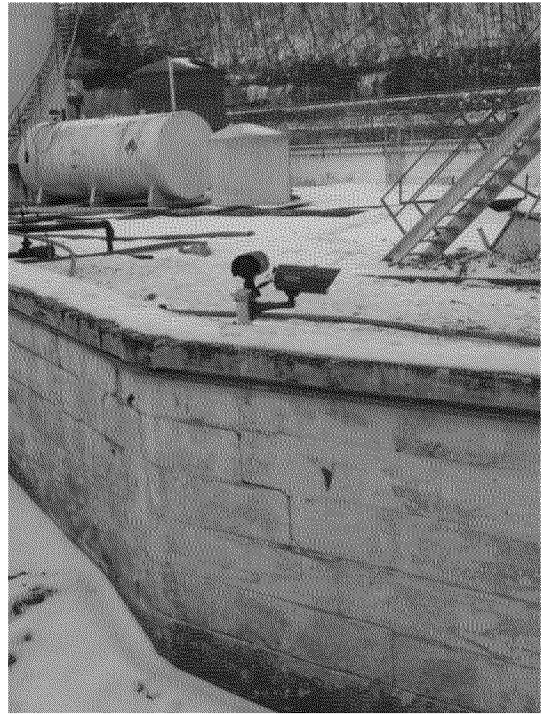
Photo No. IMG_1251; Taken on 01/28/14 at 8:26 hours by START GN. Surveillance cameras installed.

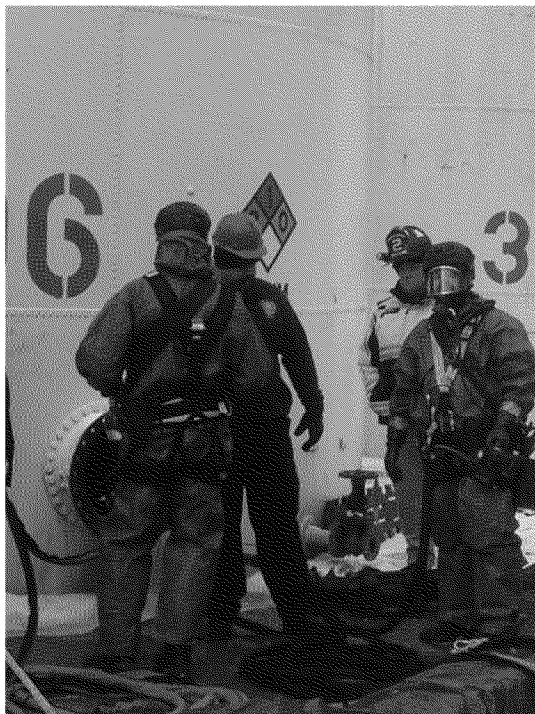
Photo No. IMG_1273; Taken on 01/28/14 at 14:37 hours by START GN. Confined space entry team.

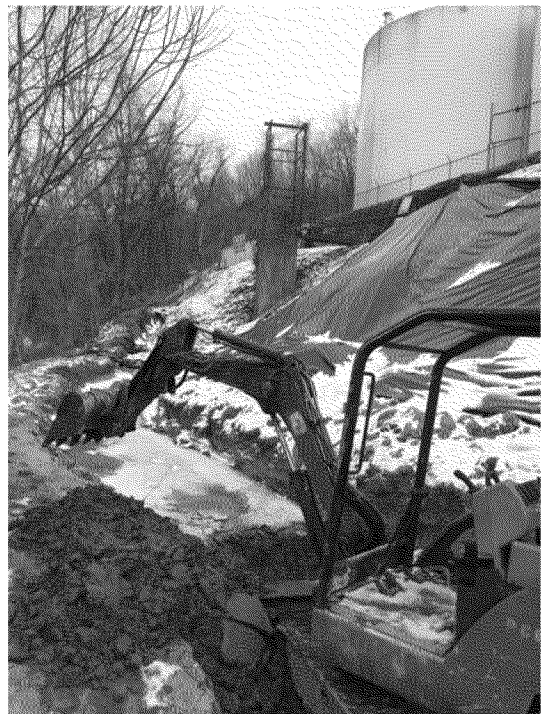
Photo No. IMG_3563; Taken on 01/28/14 at 14:45 hours by START SG. Perspective view - hole for sump in containment trench.

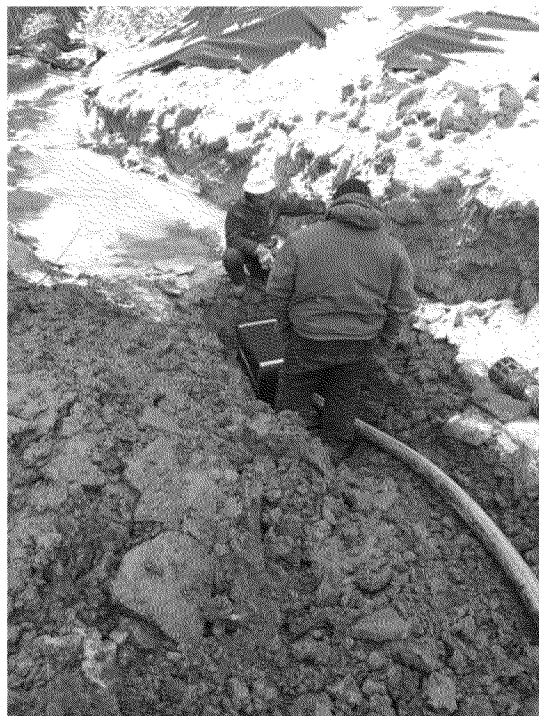
Photo No. IMG_3566; Taken on 01/28/14 at 14:58 hours by START SG. Sump installed in the bottom of the containment trench.

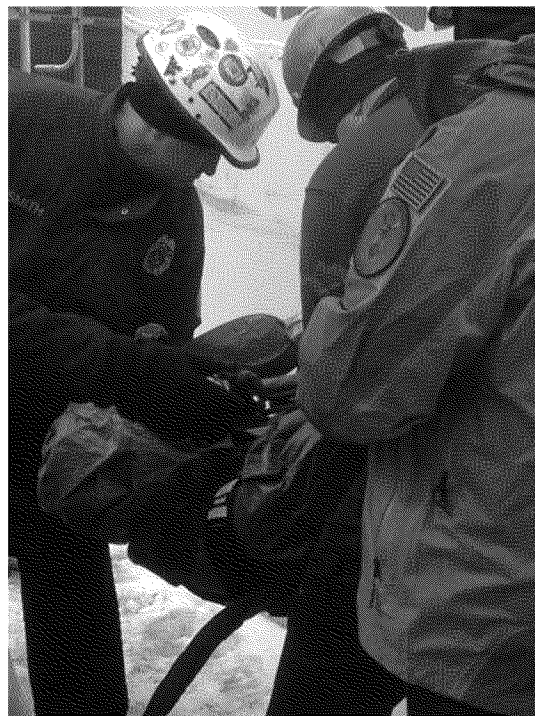
Photo No. IMG_1278; Taken on 01/28/14 at 14:58 hours by START GN. Making entry into Tank 396 through manway.

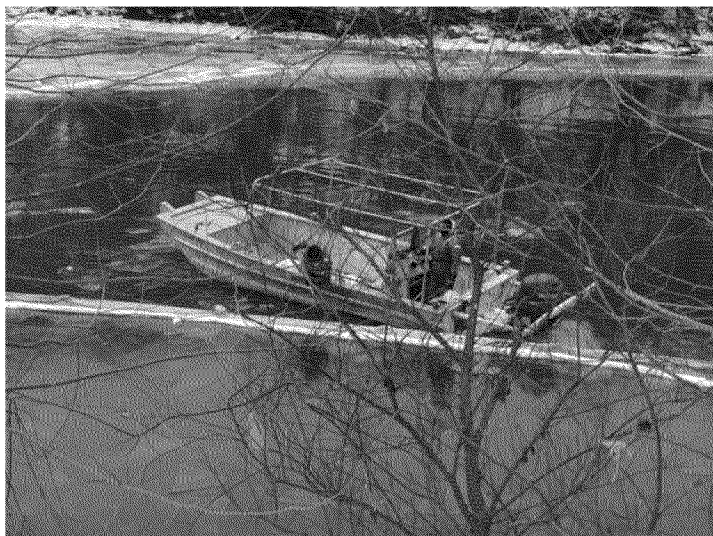
Photo No. IMG_3570; Taken on 01/28/14 at 15:31 hours by START SG. Clean Harbors clearing ice from outside the boom. This will allow access to the boom if needed.

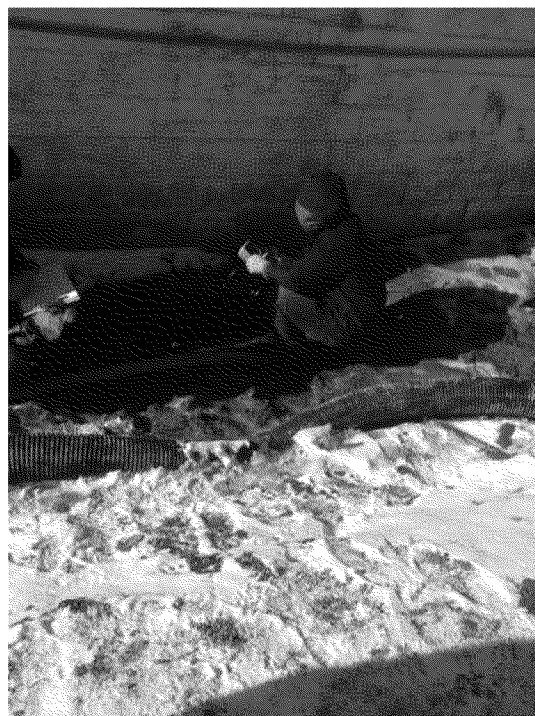
Photo No. IMG_1292; Taken on 01/29/14 at 15:01 hours by START GN. CEC measuring WQ parameters for sample "CU".

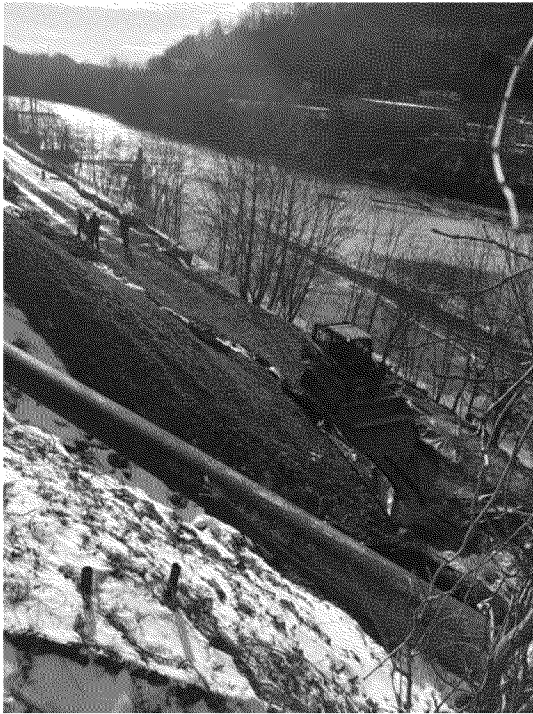
Photo No. IMG_0016; Taken on 01/30/14 at 15:49 hours by START GN. Constructing french drain in containment trench.

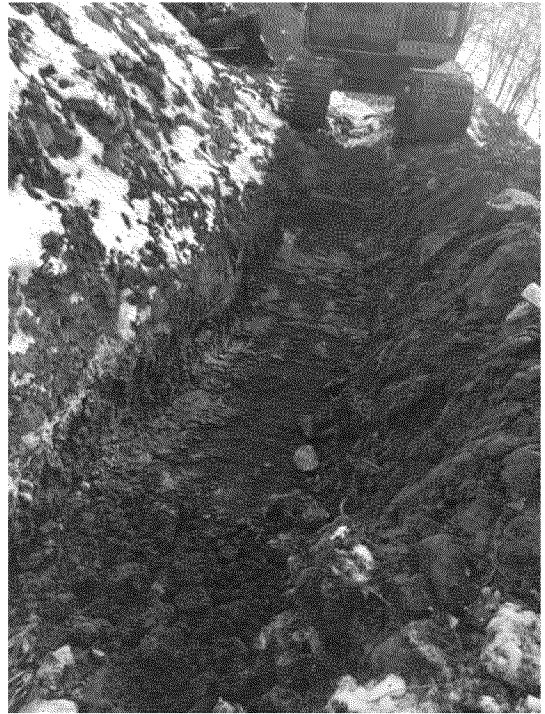
Photo No. IMG_0020; Taken on 01/30/14 at 17:10 hours by START GN. Northern trench excavated to clay below rip rap layer.

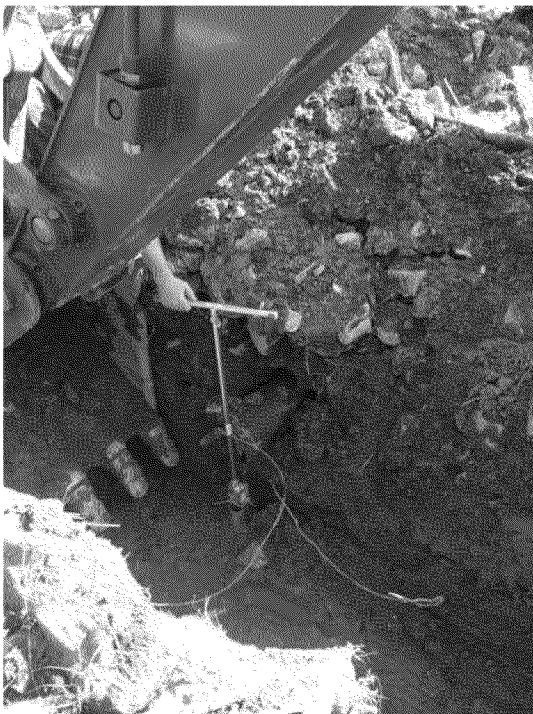
Photo No. IMG_0045; Taken on 01/31/14 at 12:50 hours by START GN. Collecting sample "Pipe-1" using 8-oz jar zip-tied to auger.

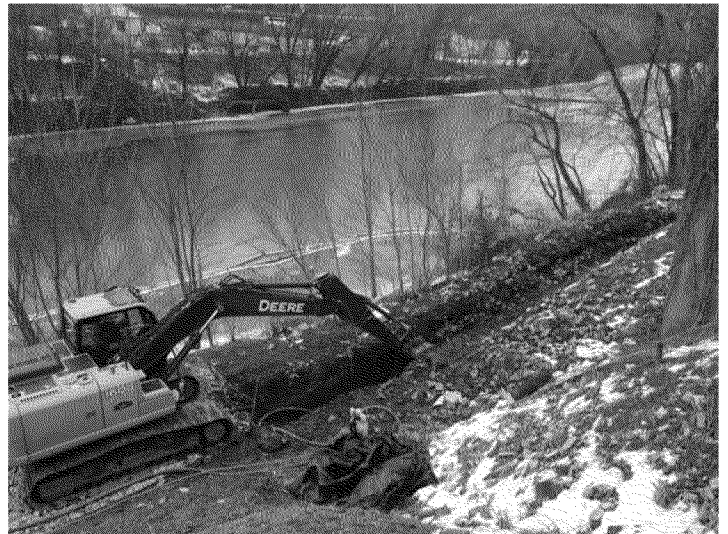
Photo No. IMG_0049; Taken on 01/31/14 at 15:10 hours by START GN. New deeper trench excavation area.

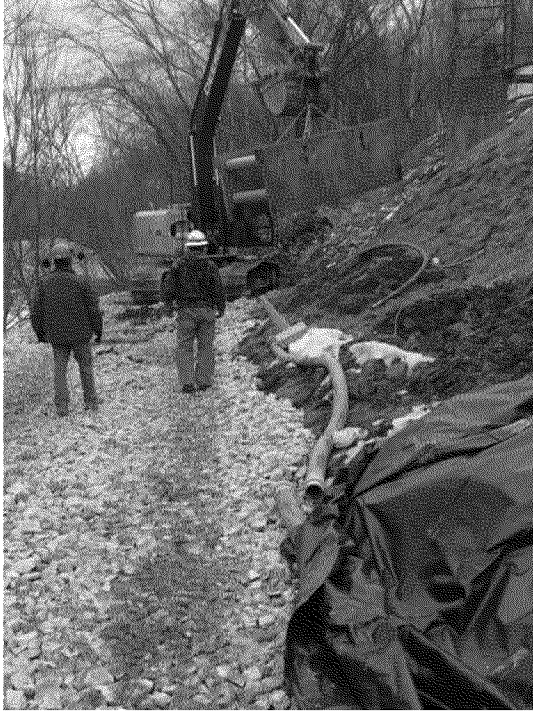
Photo No. IMG_0058; Taken on 01/31/14 at 16:51 hours by START GN. Preparing to install trench box in excavation.

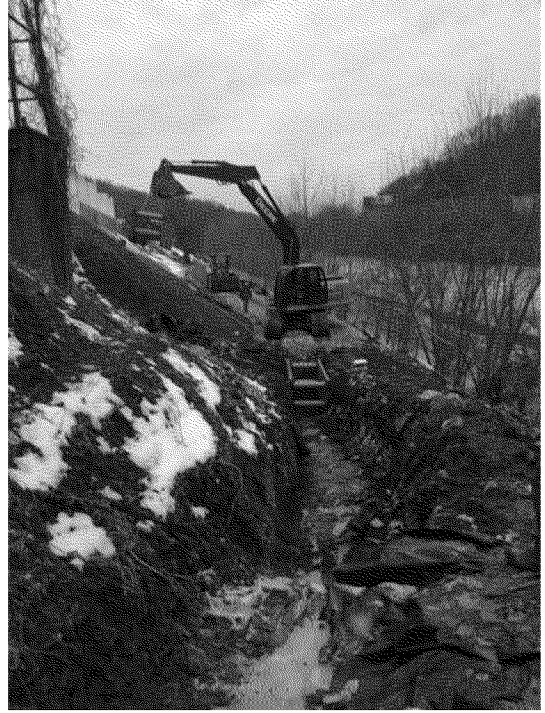
Photo No. IMG_0062; Taken on 01/31/14 at 17:07 hours by START GN. Installing second trench box in excavation.

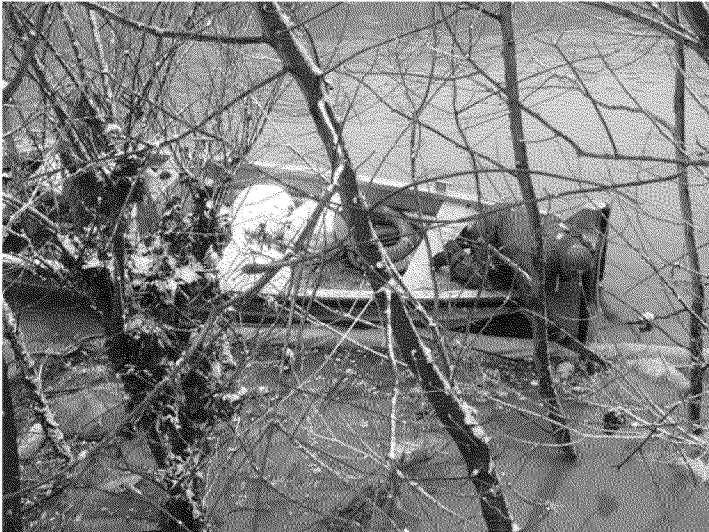
Photo No. IMG_3627; Taken on 02/03/14 at 8:26 hours by START SG. Clean Harbors during ice management at the boom on the river.

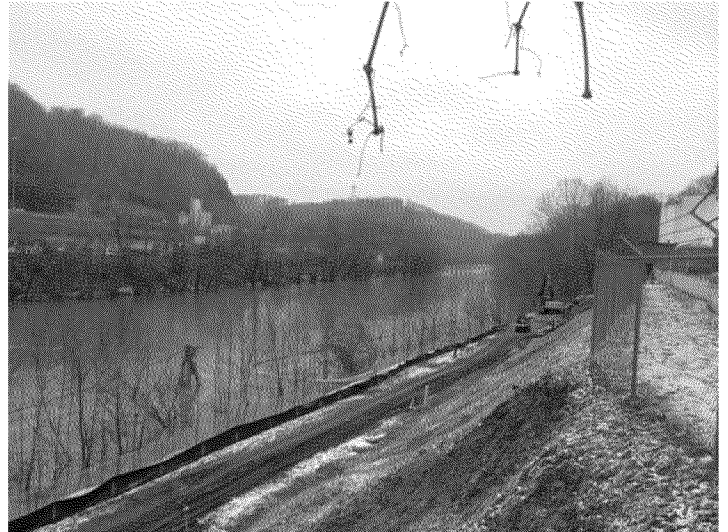
Photo No. IMG_3628; Taken on 02/04/14 at 8:37 hours by START SG. View of the rising waters in the Elk River.

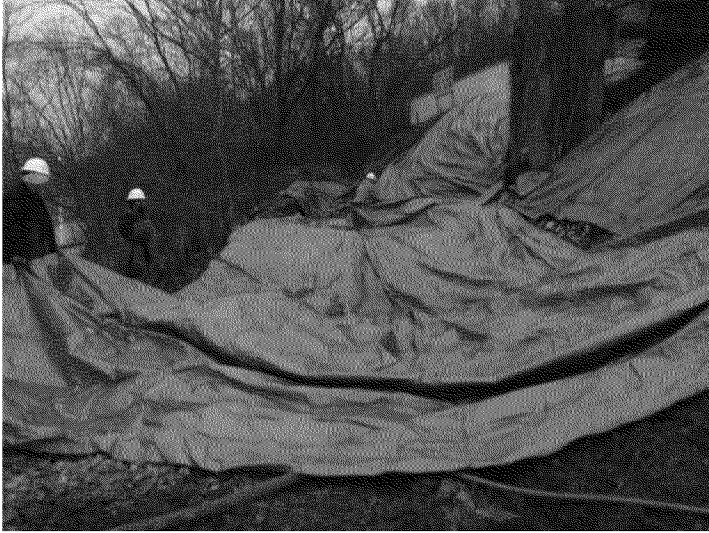
Photo No. IMG_0161; Taken on 02/04/14 at 8:00 hours by
START GN. Placing tarp over plywood cover over trench.

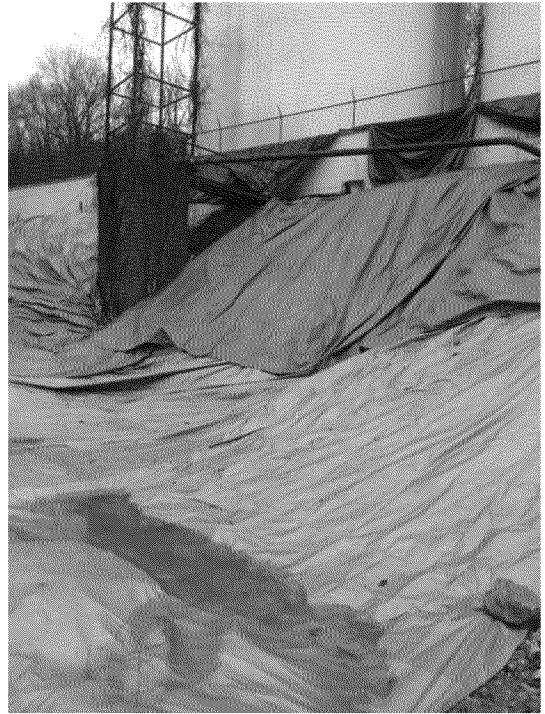
Photo No. IMG_0171; Taken on 02/05/14 at 8:28 hours by
START GN. Tarps placed on hill side and over trench area.

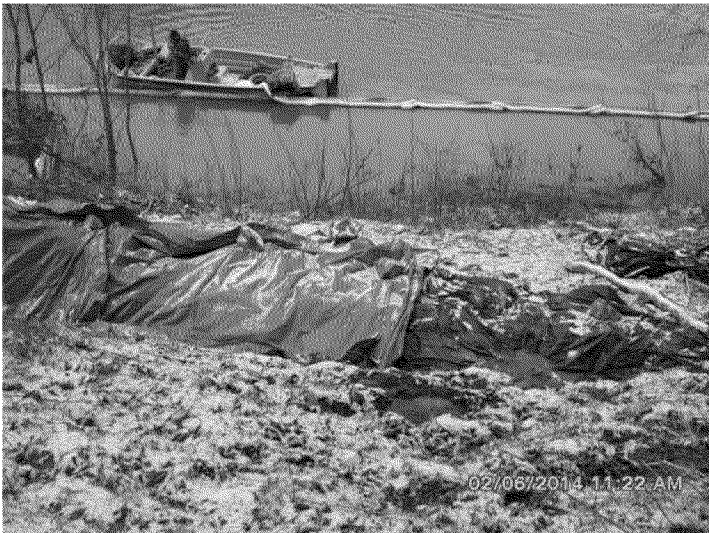
Photo No. SAM_1867; Taken on 02/06/14 at 11:24 hours by
START MD. Clean Harbors changing out the boom on the Elk
River.

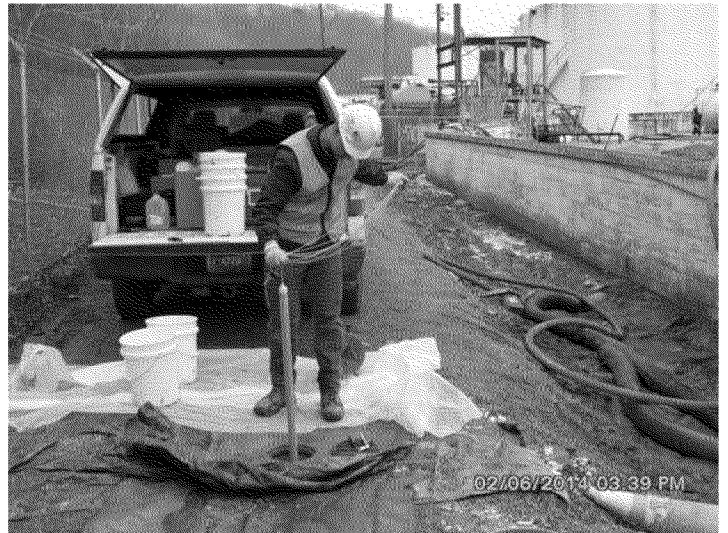
Photo No. SAM_1878; Taken on 02/06/14 at 16:12 hours by
START MD. Diversified sampling the monitoring wells.

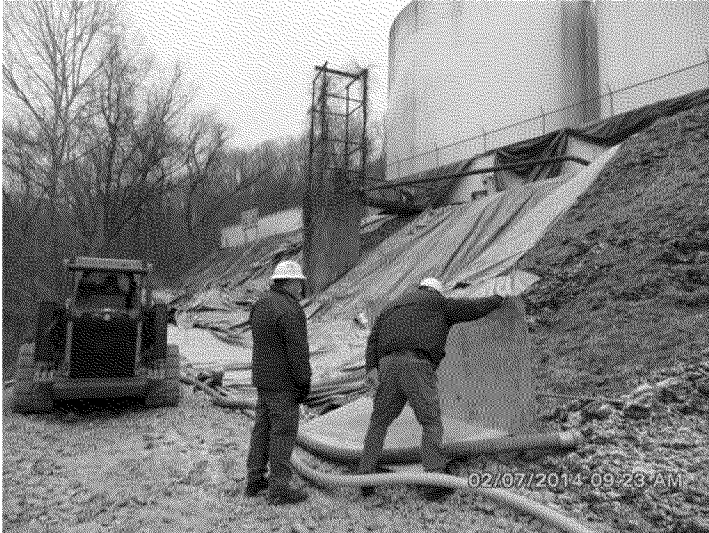
Photo No. SAM_1893; Taken on 02/07/14 at 9:23 hours by START MD. WVDEP inspecting the site near the intercept trench

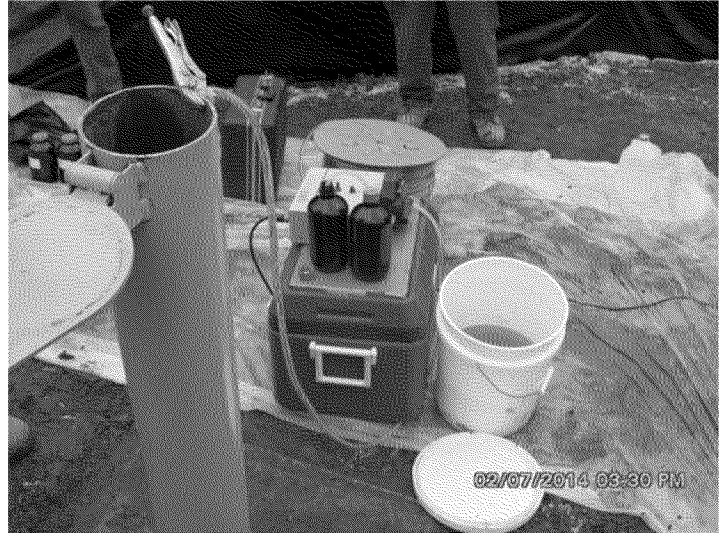
Photo No. SAM_1919; Taken on 02/07/14 at 13:36 hours by START MD. Diversified sampling the monitoring wells.

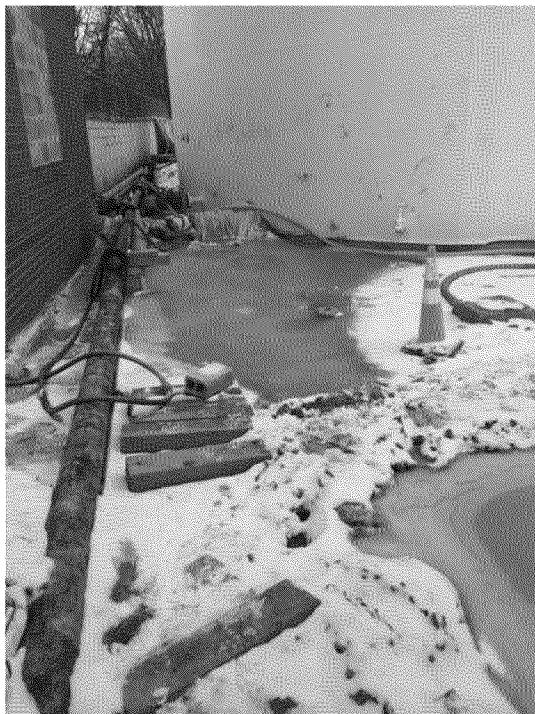
Photo No. IMG_0246; Taken on 02/11/14 at 9:06 hours by START GN. Ice on standing water inside tank containment area.

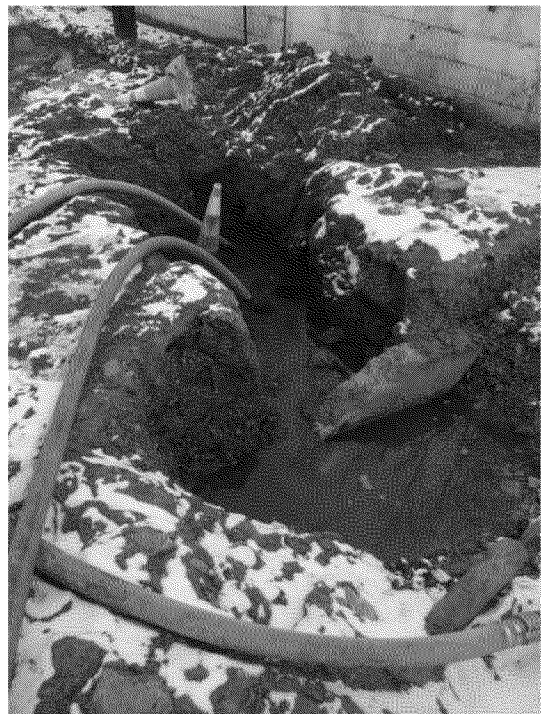
Photo No. IMG_0247; Taken on 02/11/14 at 9:06 hours by START GN. Water in sump inside tank containment area.

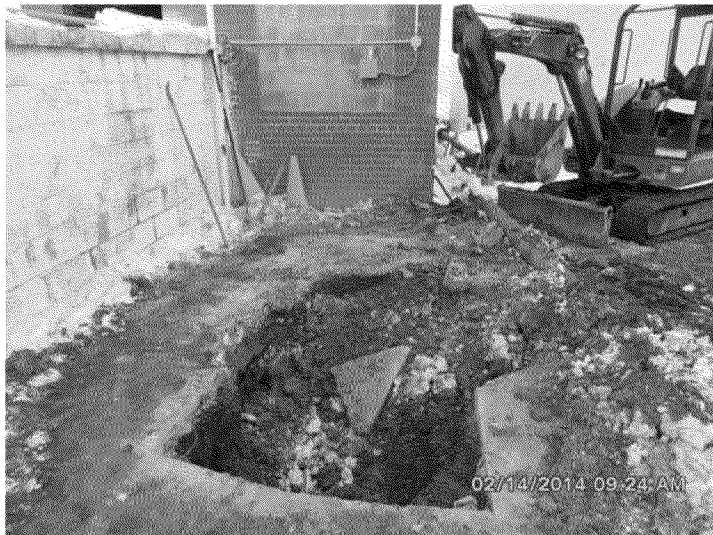
Photo No. SAM_1943; Taken on 02/14/14 at 9:24 hours by START MD. Excavation of the sump near the west containment wall, inside the wall.

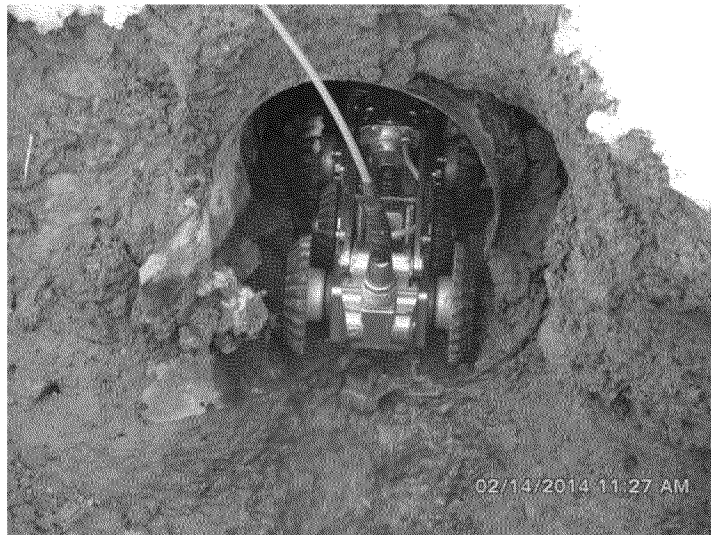
Photo No. SAM_1949; Taken on 02/14/14 at 11:28 hours by START MD. A robotic camera entering the culvert pipe.

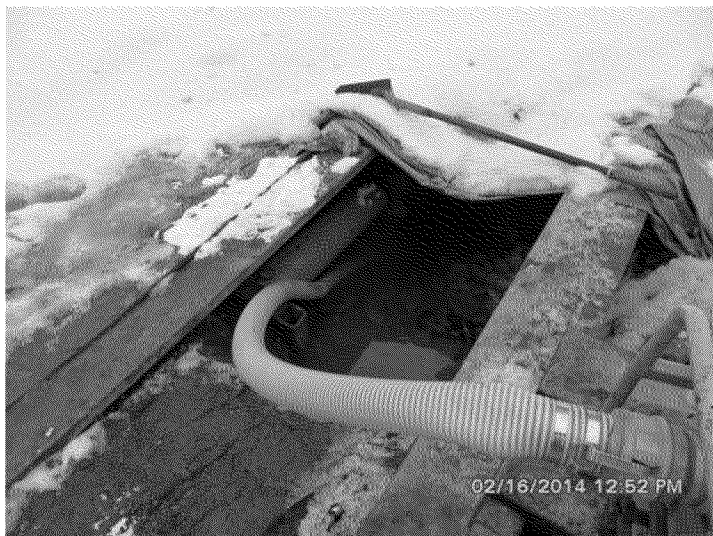
Photo No. SAM_1979; Taken on 02/16/14 at 13:07 hours by START MD. Water in the intercept trench.

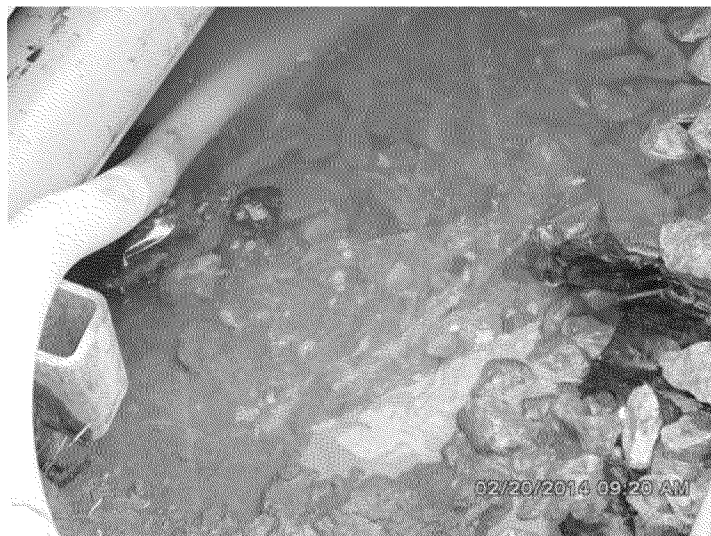
Photo No. SAM_2060; Taken on 02/20/14 at 9:29 hours by START MD. Product sheen visible on the water in the intercept trench.

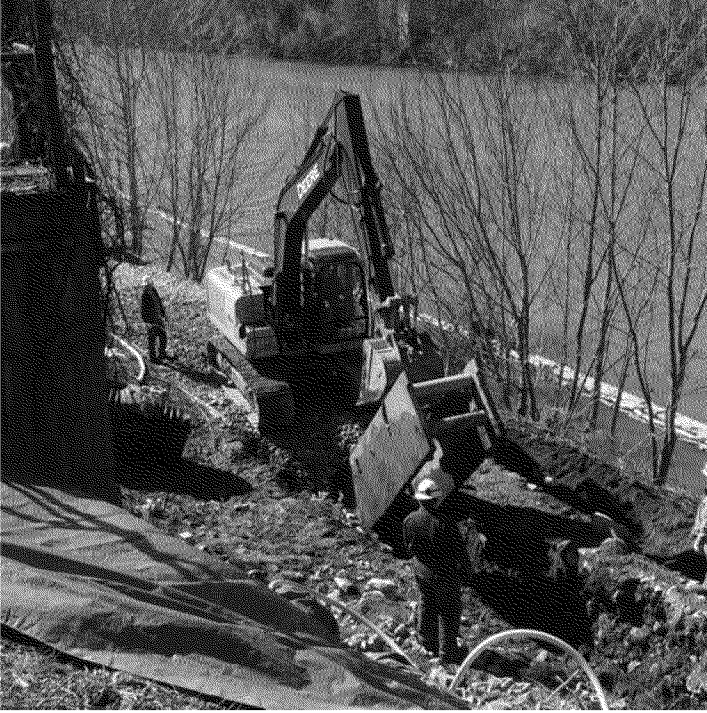
Photo No. IMG_0289; Taken on 02/24/14 at 13:23 hours by START GN. Removing second trench box.

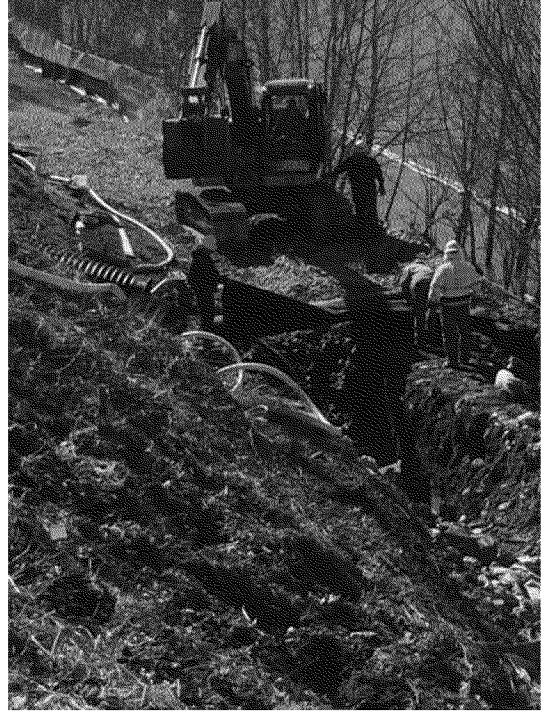
Photo No. IMG_0296; Taken on 02/24/14 at 13:45 hours by START GN. Laying out HDPE liner to install in trench.

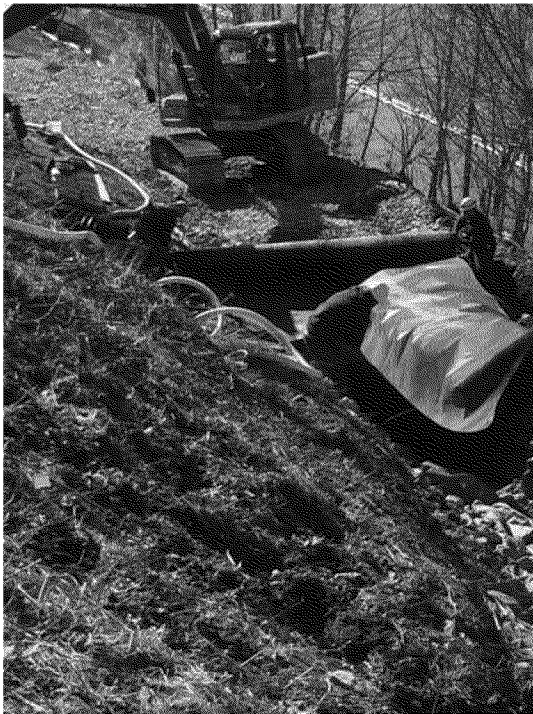
Photo No. IMG_0302; Taken on 02/24/14 at 13:47 hours by START GN. Installing HDPE liner to install in trench.

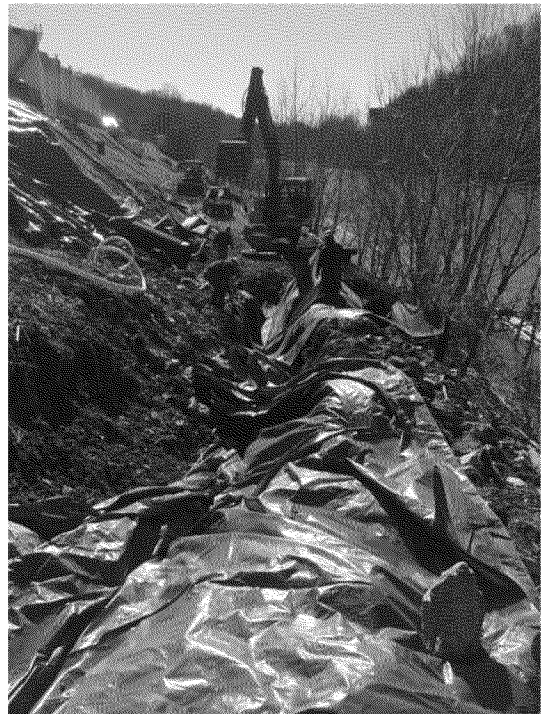
Photo No. IMG_0324; Taken on 02/24/14 at 14:27 hours by START GN. Installing geotextile fabric layer in trench.

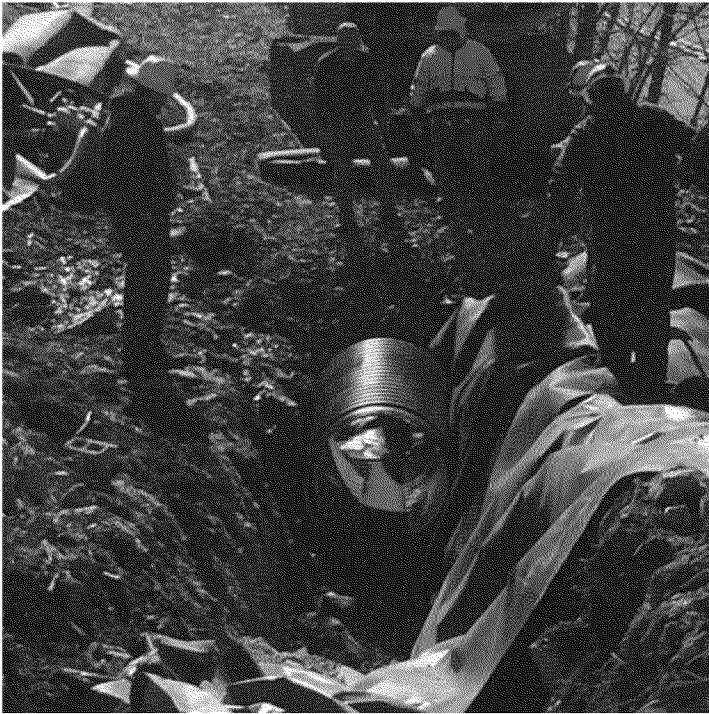
Photo No. IMG_0330; Taken on 02/24/14 at 14:32 hours by START GN. Sump pipe in trench.

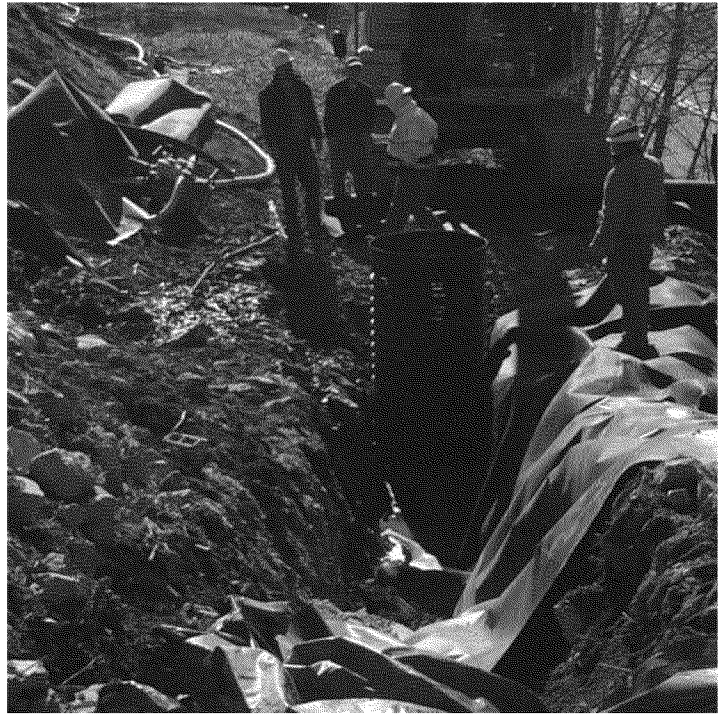
Photo No. IMG_0332; Taken on 02/24/14 at 14:35 hours by START GN. Installing perforated 36-inch vertical pipe in trench sump.

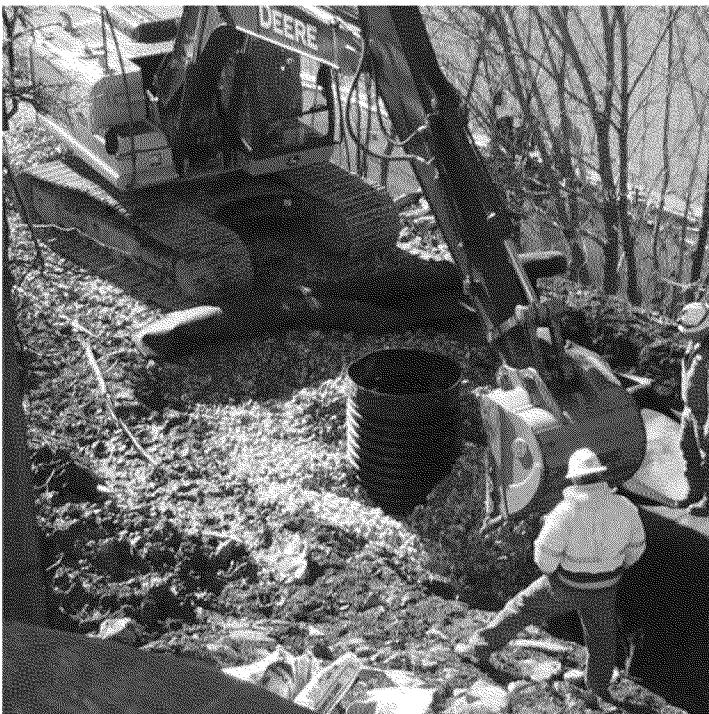
Photo No. IMG_0338; Taken on 02/24/14 at 14:52 hours by START GN. Placing rock around sump pipe.

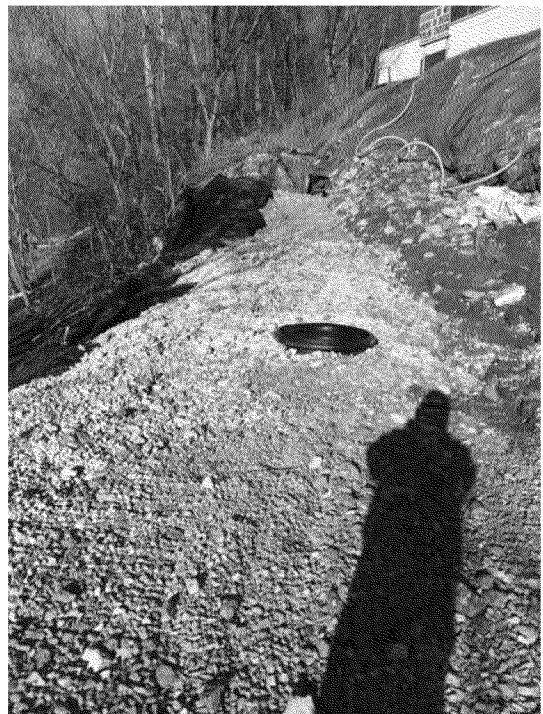
Photo No. IMG_0352; Taken on 02/24/14 at 16:22 hours by START GN. Installed trench sump pipe.

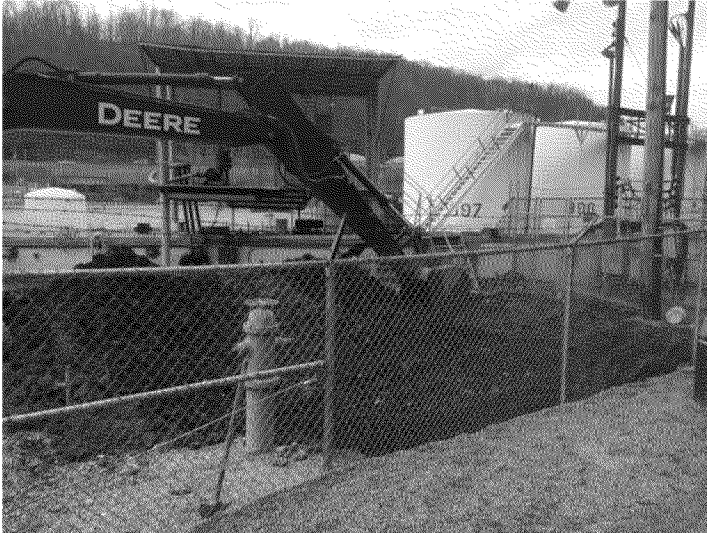
Photo No. IMG_0366; Taken on 02/25/14 at 16:16 hours by START GN. Excavating 6-9" soil/gravel in vac trailer parking area.

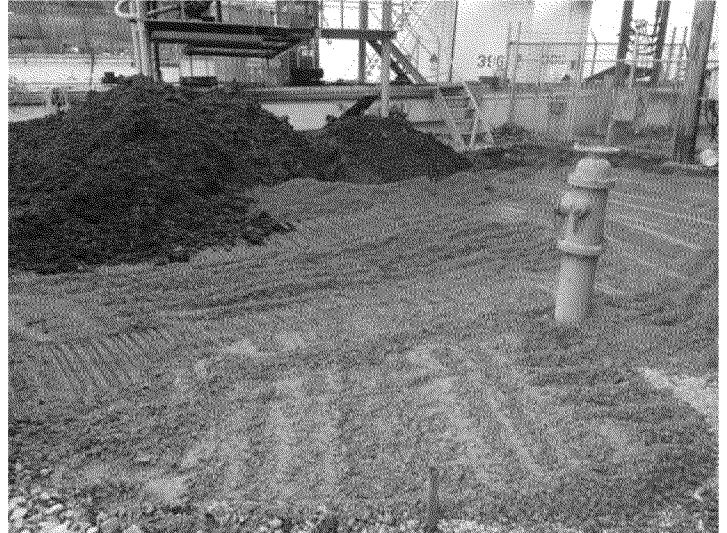
Photo No. IMG_0372; Taken on 02/25/14 at 16:58 hours by START GN. Gravel spread in excavated area.

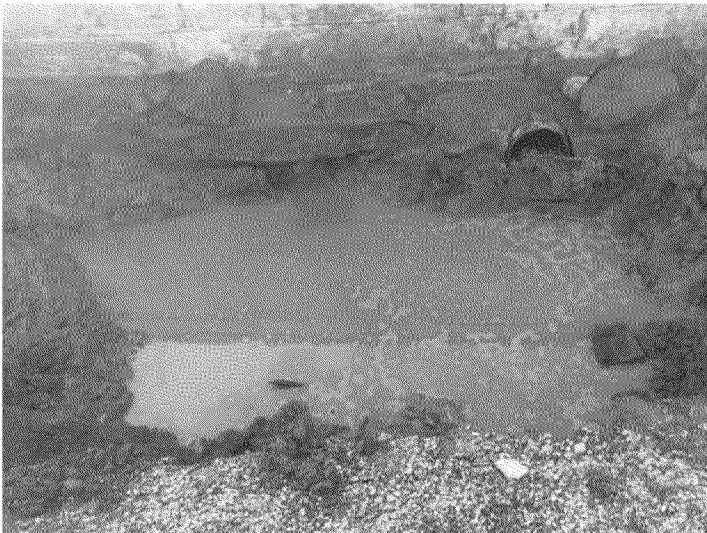
Photo No. IMG_0387; Taken on 02/26/14 at 17:13 hours by START GN. Water discharging from under footer of containment wall east side and filling hole.

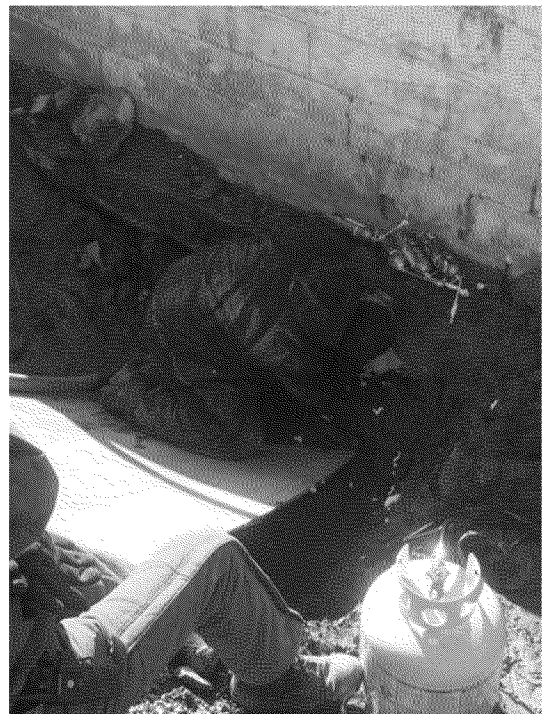
Photo No. IMG_0398; Taken on 02/27/14 at 15:15 hours by START GN. RP contractors sealing culvert - east wall.

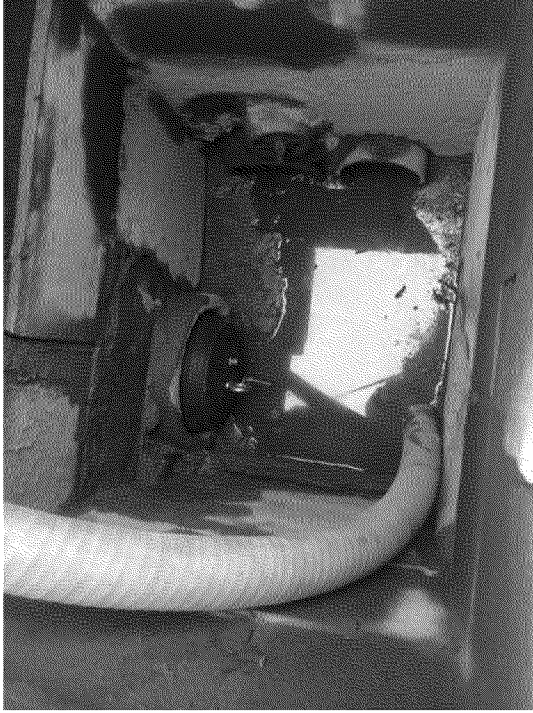
Photo No. IMG_0407; Taken on 03/01/14 at 17:22 hours by
START GN. Inflatable plug installed in oil water separator
sump.
